World Trade Center Building Performance Study:

*Data Collection, Preliminary
Observations, and
Recommendations*

FEMA 403 / May 2002

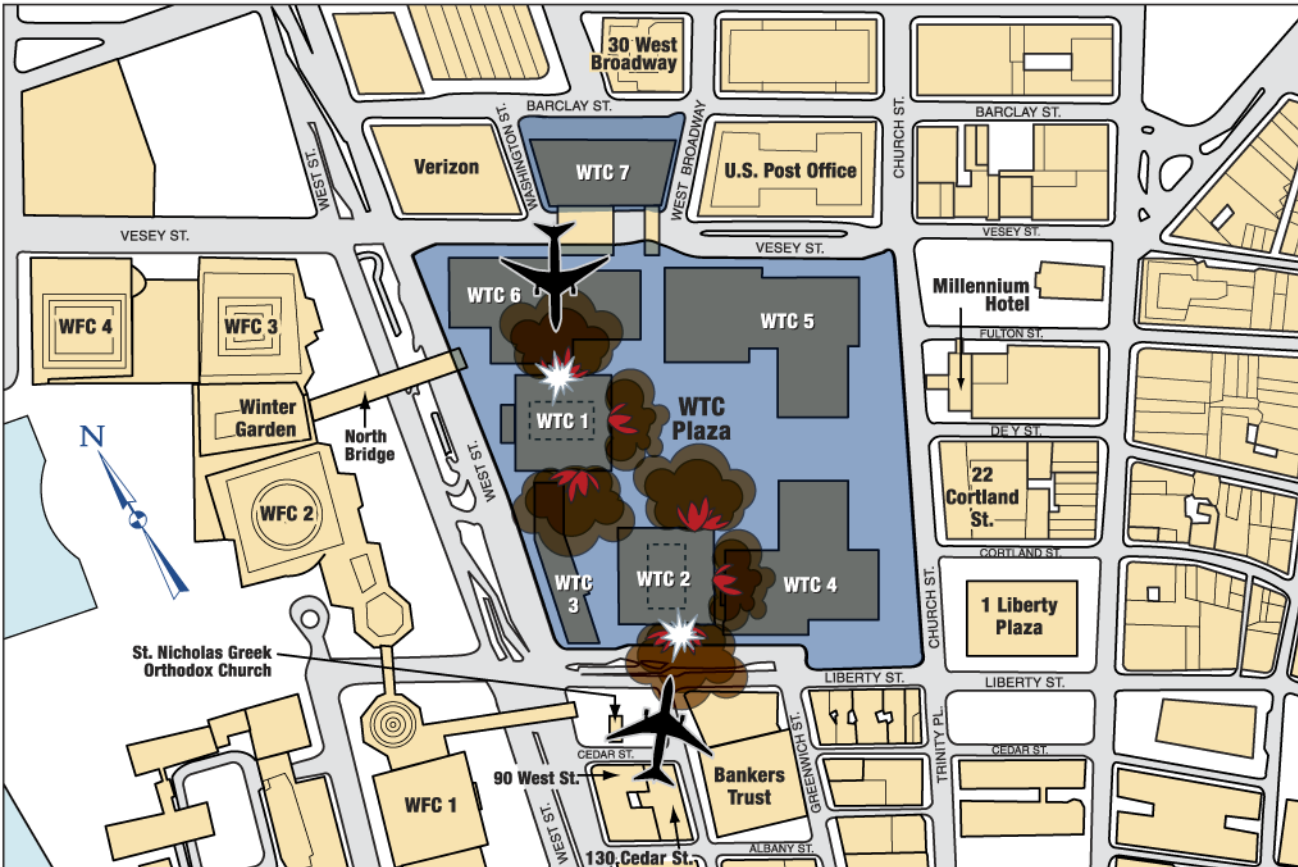
Figure 1-3 WTC impact locations and resulting fireballs.

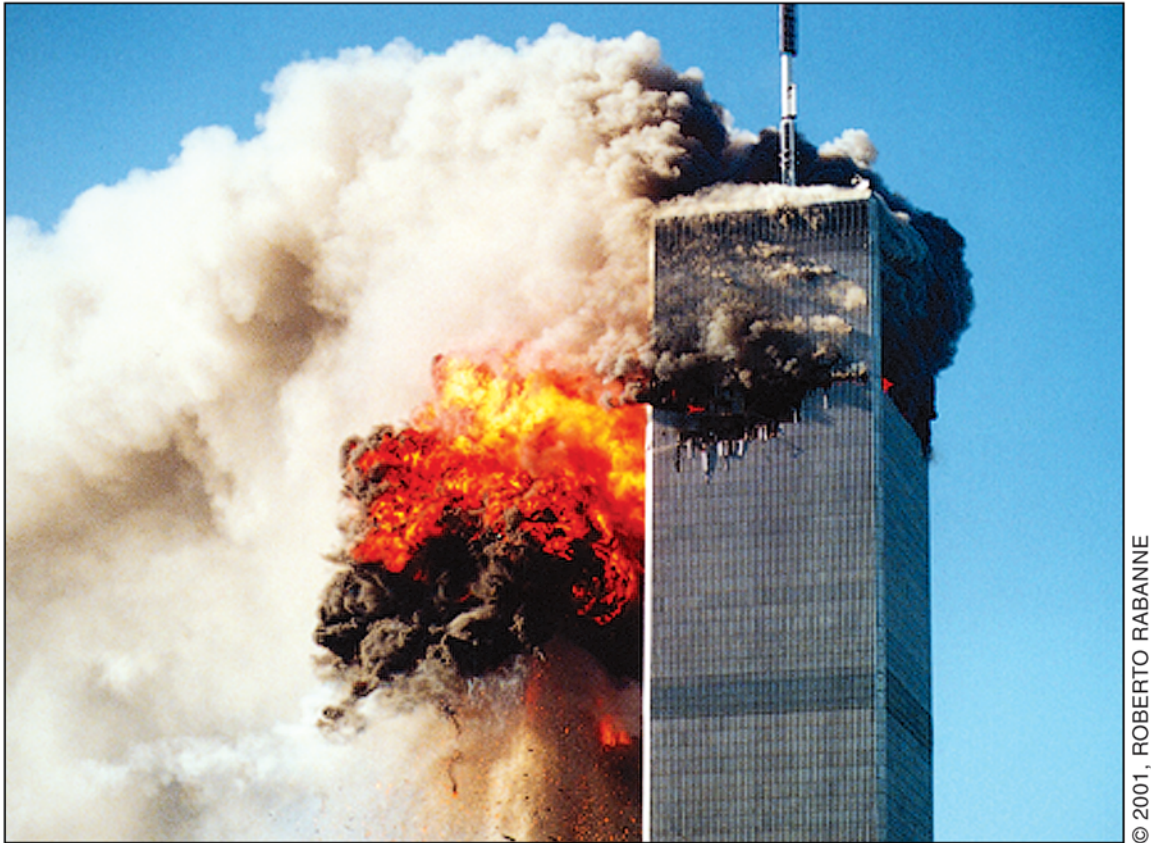
Figure 1-5 Fireball erupts on the north face of WTC 2 as United Airlines Flight 175 strikes the building.

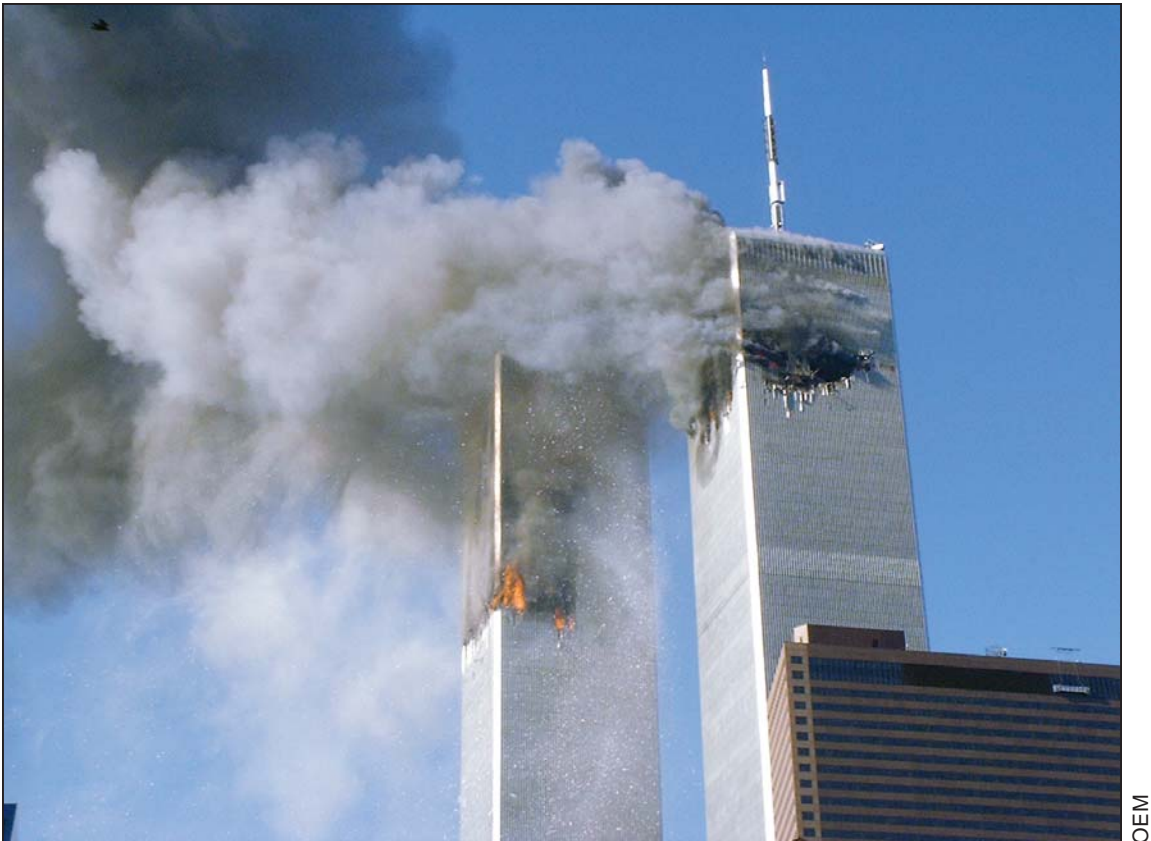
Figure 1-6 View of the north and east faces showing fire and impact damage to both towers.

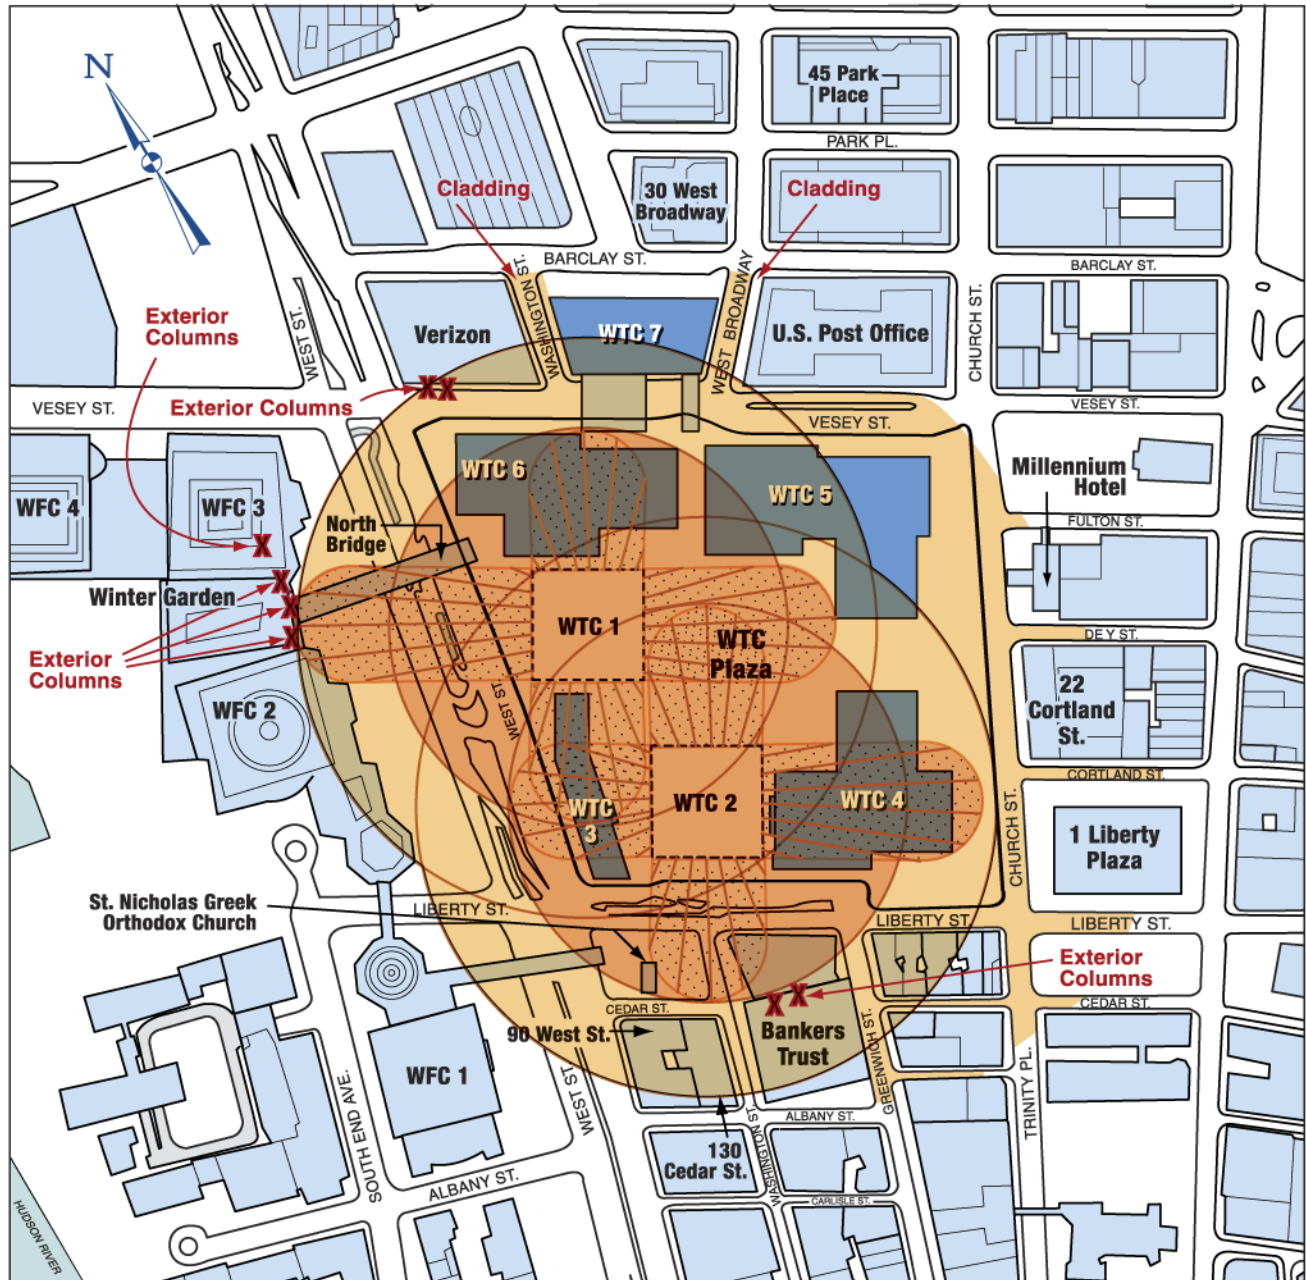
Debris from the collapsing towers, some of it still on fire, rained down on surrounding buildings, causing structural damage and starting new fires (Figure 1-7). The sudden collapse of each tower sent out air pressure waves that spread dust clouds of building materials in all directions for many blocks. The density and pressure of the dust clouds were strong enough to carry light debris and lift or move small vehicles and break windows in adjacent buildings for several blocks around the WTC site. Most of the fires went unattended as efforts were devoted to rescuing those trapped in the collapsed towers. The 22-story Marriott World Trade Center Hotel (WTC 3) was hit by a substantial amount of debris during both tower collapses. Portions of WTC 3 were severely damaged by debris from each tower collapse, but progressive collapse of the building did not occur. However, little of WTC 3 remained standing after the collapse of WTC 1. WTC 4, 5, and 6 had floor contents and furnishings burn completely and suffered significant partial collapses from debris impacts and from fire damage to their structural frames. WTC 7, a 47-story building that was part of the WTC complex, burned unattended for 7 hours before collapsing at 5:20 p.m. The falling debris also damaged water mains around the WTC site at the following locations:

Figure 1-7 Schematic depiction of areas of collapse debris impact, based on aerial photographs and documented damage. Striped areas indicate predominant locations of exterior steel columns. Inner circles indicate approximate radius of exterior steel columns and other heavy debris. Outer circles indicate approximate radius of aluminum cladding and other lighter debris. Heavy Xs show where exterior steel columns were found outside the predominate debris areas.

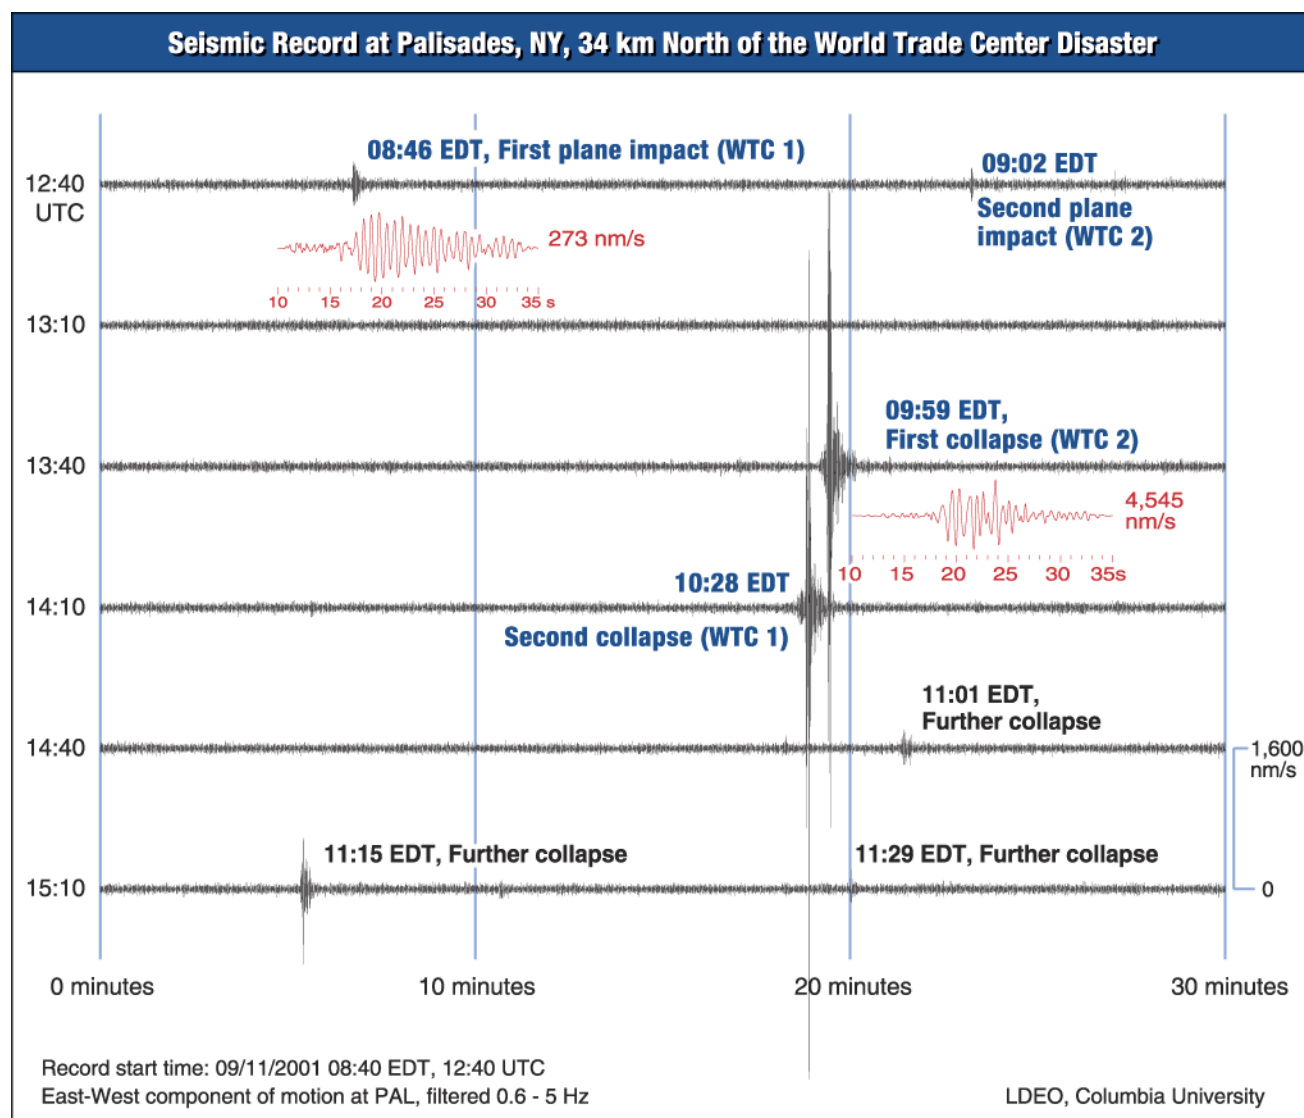
Figure 1-8 Seismic recordings on east-west component at Palisades, NY, for events at WTC on September 11, 2001, distance 34 km. Three hours of continuous data are shown starting at 08:40 EDT (12:40 UTC). The two largest signals were generated by the collapses of towers 1 and 2. Expanded views of first impact and first collapse are shown in red. The amplitude of the seismic signal is in nanometers per second (nm/s), and the peak amplitude of the ground motion at this station reached to 4,545 nm/s for the first collapse. Note the relatively periodic motions for impacts 1 and 2.

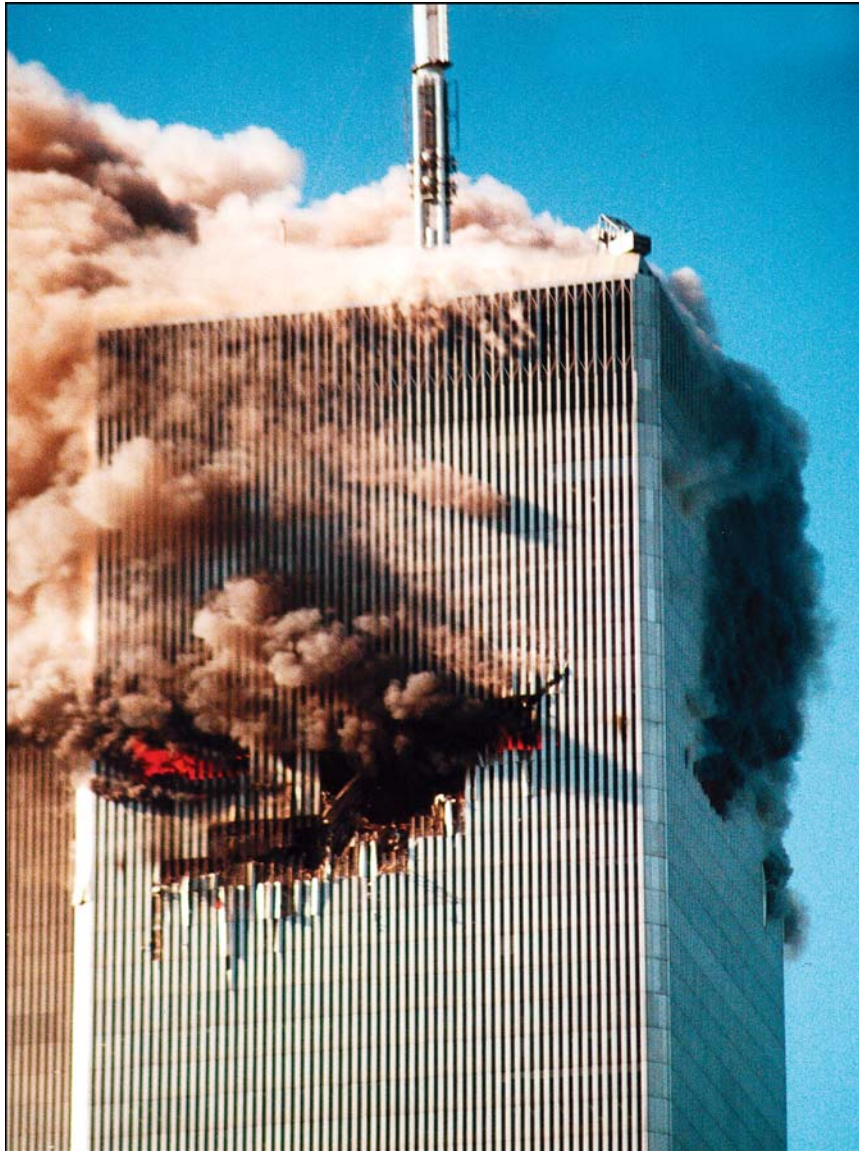
American Airlines Flight 11 struck the north face of WTC 1 approximately between the 94th and 98th floors (Figures 2-13 and 2-14), causing massive damage to the north face of the building within the immediate area (Figure 2-15). At the central zone of impact corresponding to the airplane fuselage and engines, at least five of the prefabricated, three-column sections that formed the exterior walls were broken loose of the structure, and some were pushed inside the building envelope. Locally, floors supported by these exterior wall sections appear to have partially collapsed, losing their support along the exterior wall. Away from this central zone, in areas impacted by the outer wing structures, the exterior columns were fractured by the force of the collision. Interpretation of photographic evidence suggests that from 31 to 36 columns on the north building face were destroyed over portions of a four-story range. Partial collapse of floors in this zone appear to have occurred over a horizontal length of wall of approximately 65 feet, while floors in other portions of the building appear to have remained intact. Figure 2-16 shows the damage to the exterior columns on the impacted face of WTC 1.

Figure 2-13 Zone of aircraft impact on the north face of WTC 1.

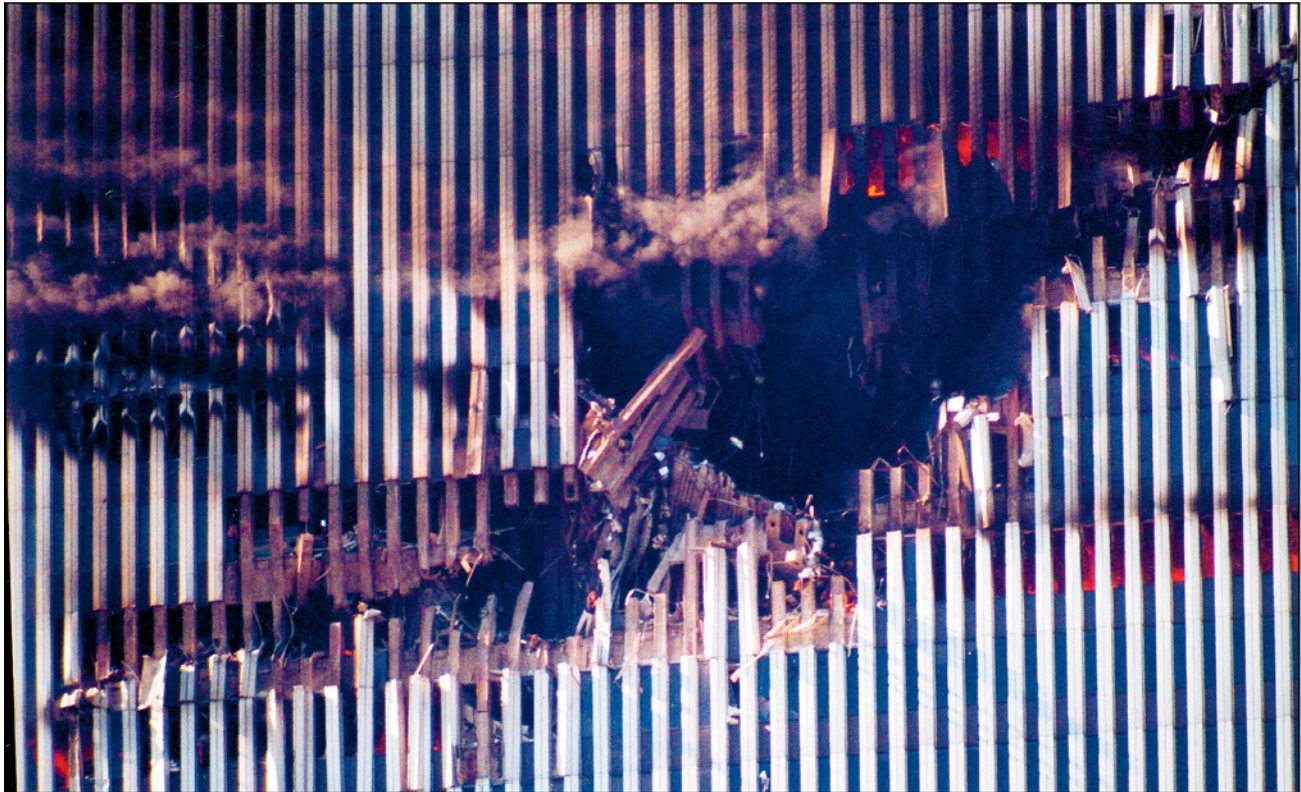
Figure 2-15 Impact damage to the north face of WTC 1.

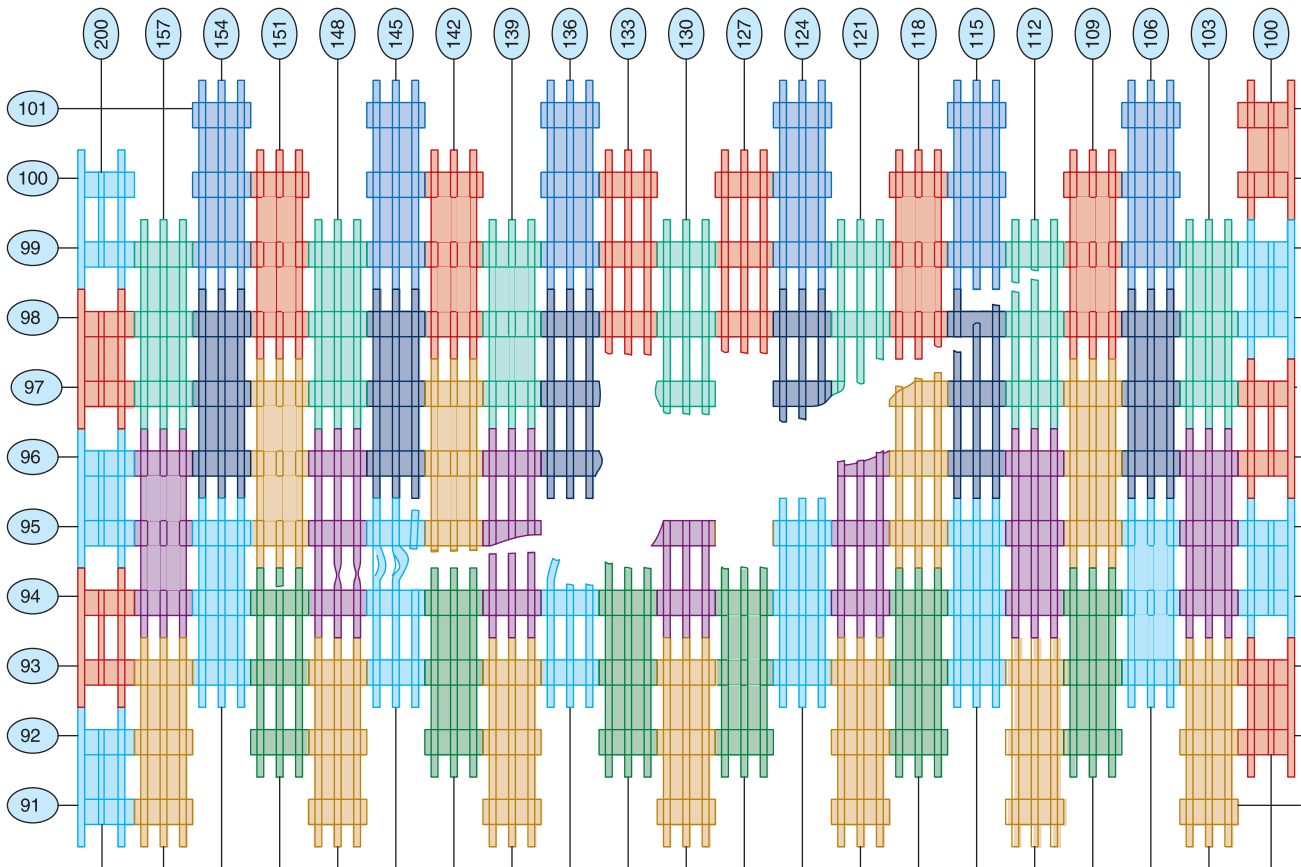
GENERAL NOTES: (1) Column damage captured from photographs and enhanced videos. (2) Damage to column lines 111-115 at level 98 is estimated.

Figure 2-16 Impact damage to exterior columns on the north face of WTC 1.

compression were successfully transferred to other load paths. Most of the load supported by the failed columns is believed to have transferred to adjacent perimeter columns through Vierendeel behavior of the exterior wall frame. Preliminary structural analyses of similar damage to WTC 2 suggests that axial load demands on columns immediately adjacent to the destroyed columns may have increased by as much as a factor of 6 relative to the load state prior to aircraft impact. However, these exterior columns appear to have had substantial overstrength for gravity loads.

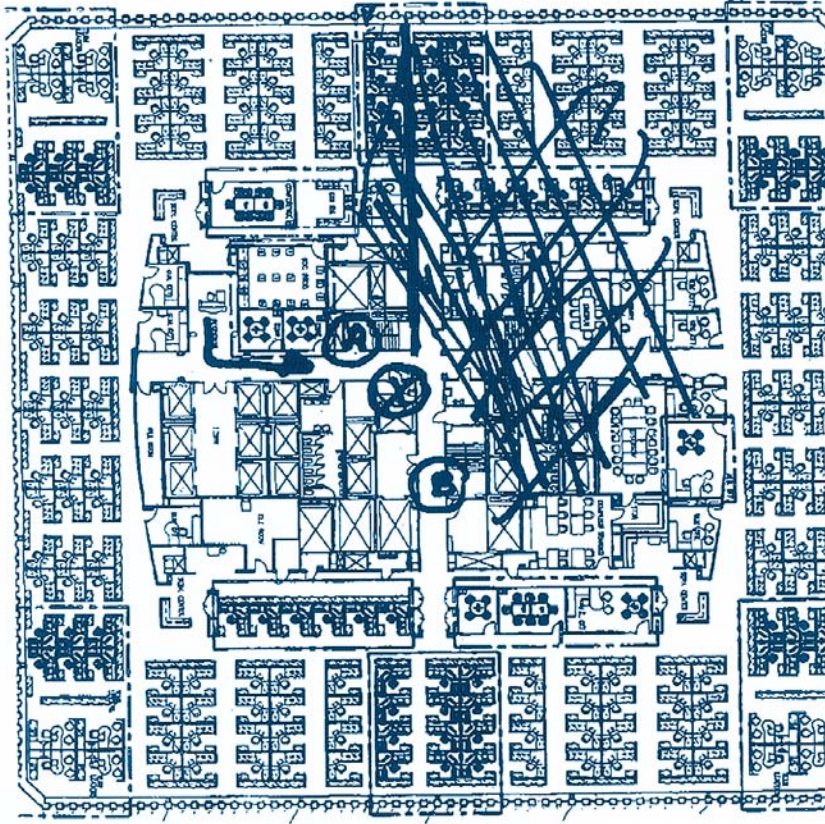
In addition to this damage at the building perimeter, a significant but undefined amount of damage also occurred to framing at the central core. Interviews were conducted with persons who were present in offices on the 91st floor of the building at the north face of the structure, three floors below the approximate zone of impact. Their descriptions of the damage evident at this floor level immediately following the aircraft impact suggest relatively slight damage at the exterior wall of the building, but progressively greater damage to the south and east. They described extensive building debris in the eastern portion of the central core, preventing their access to the easternmost exit stairway. This suggests the possibility of immediate partial collapse of framing in the central core. These persons also described the presence of debris from collapsed partition walls from upper floors in stairways located further to the west, suggesting the possibility of some structural damage in the northwestern portion of the core framing as well. Figure 2-17 is a sketch made during an interview with building occupants indicating portions of the 91st floor that could not be accessed due to accumulated debris.

Figure 2-17
Approximate debris location on the 91st
floor of WTC 1.

Air supply to support the fires was primarily provided by openings in the exterior walls that were created by the aircraft impacts and fireballs, as well as by additional window breakage from the ensuing heat of the fires. Table 2.1 lists the estimated exterior wall openings used in these calculations. Although the table shows the openings on a floor-by-floor basis, several of the openings, particularly in the area of impact, actually spanned several floors (see Figure 2-17).

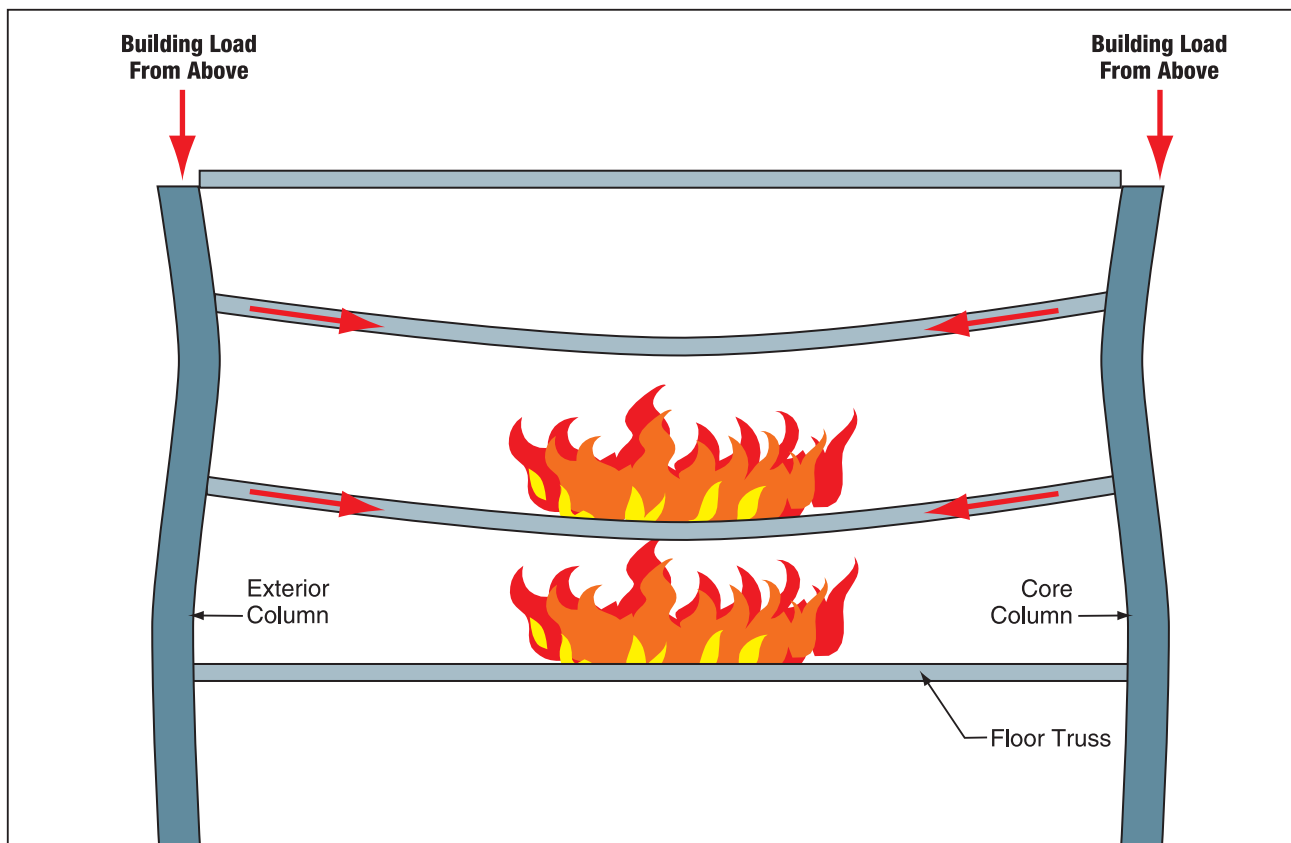
- As the temperature of floor slabs and support framing increases, these elements can lose rigidity and sag into catenary action. As catenary action progresses, horizontal framing elements and floor slabs become tensile elements, which can cause failure of end connections (Figure 2-21) and allow supported floors to collapse onto the floors below. The presence of large amounts of debris on some floors of WTC 1 would have made them even more susceptible to this behavior. In addition to overloading the floors below, and potentially resulting in a pancake-type collapse of successive floors, local floor collapse would also immediately increase the laterally unsupported length of columns, permitting buckling to begin. As indicated in Appendix B, the propensity of exterior columns to buckle would have been governed by the relatively weak bolted column splices between the vertically stacked prefabricated exterior wall units. This effect would be even more likely to occur in a fire that involves several adjacent floor levels simultaneously, because the columns could effectively lose lateral support over several stories (Figure 2-22).

Figure 2-22 Catenary action of floor framing on several floors initiates column buckling failures.

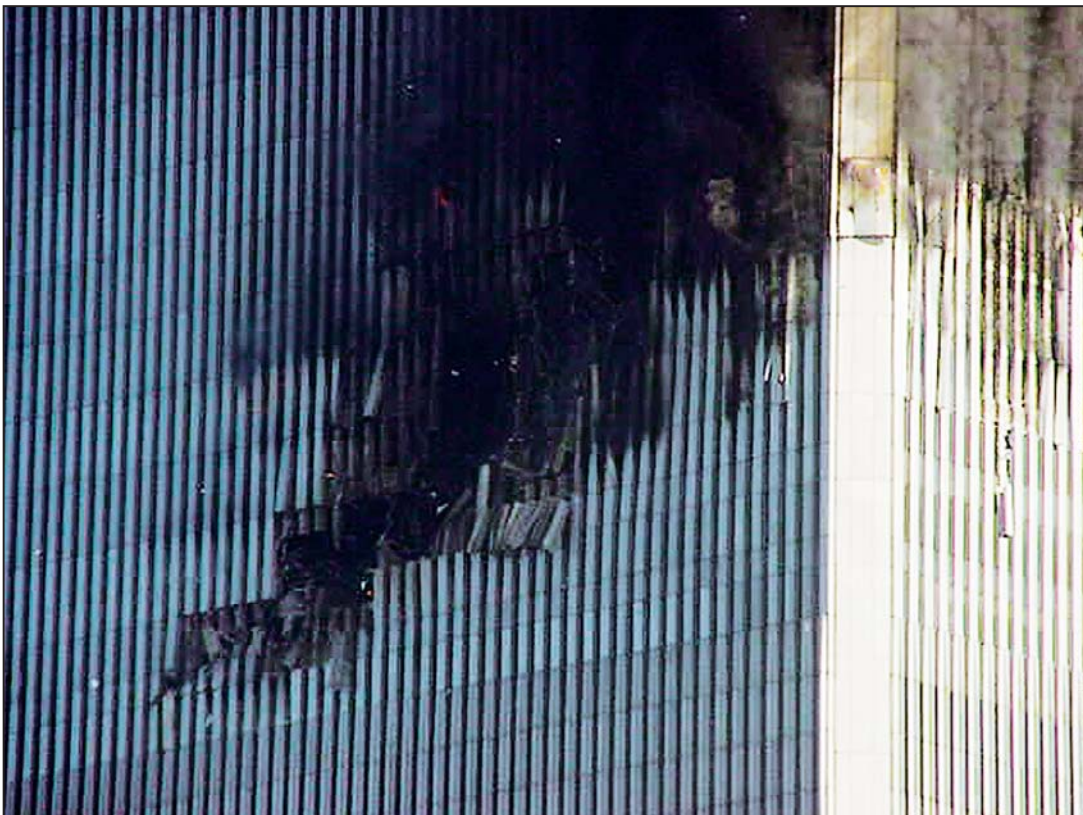
United Airlines Flight 175 struck the south face of WTC 2 approximately between the 78th and 84th floors. The zone of impact extended from near the southeast corner of the building across much of the building face (Figures 2-24 and 2-25). The aircraft caused massive damage to the south face of the building in the zone of impact (Figures 2-26 and 2-27). At the central zone of impact corresponding to the airplane fuselage and engines, six of the prefabricated, three-column sections that formed the exterior walls were broken loose from the structure, with some of the elements apparently pushed inside the building envelope. Locally, as was the case in WTC 1, floors supported by these exterior wall sections appear to have partially collapsed. Away from this central zone, in the areas impacted by the outer wing structures, the exterior steel columns

Figure 2-24 Southeast corner of WTC 2 shortly after aircraft impact.

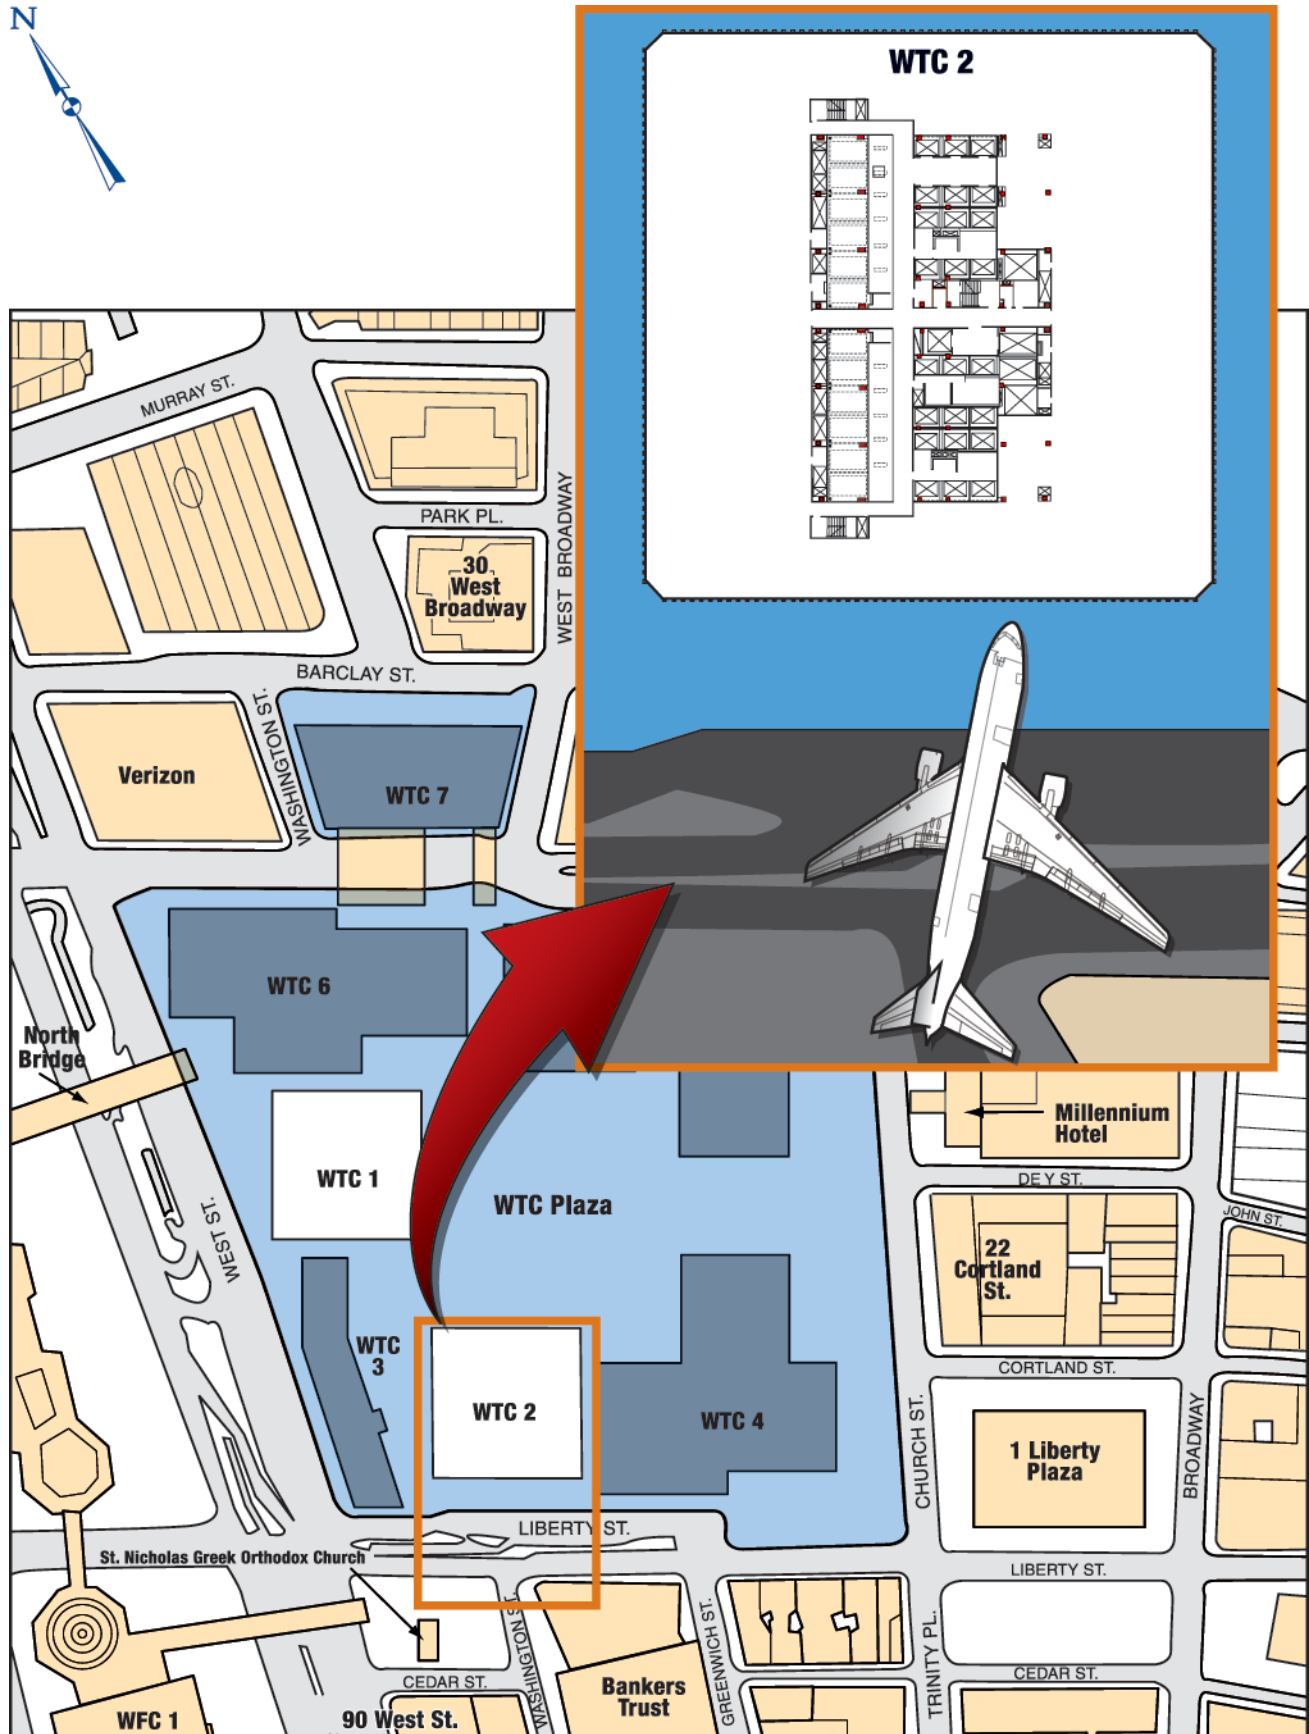
Figure 2-25 Approximate zone of impact of aircraft on the south face of WTC 2.

were fractured by the impact. Photographic evidence suggests that from 27 to 32 columns along the south building face were destroyed over a five-story range. Partial collapse of floors in this zone appears to have occurred over a horizontal length of approximately 70 feet, while floors in other portions of the building appeared to remain intact. It is probable that the columns in the southeast corner of the core also experienced some damage because they would have been in the direct travel path of the fuselage and port engine (Figure 2-25).

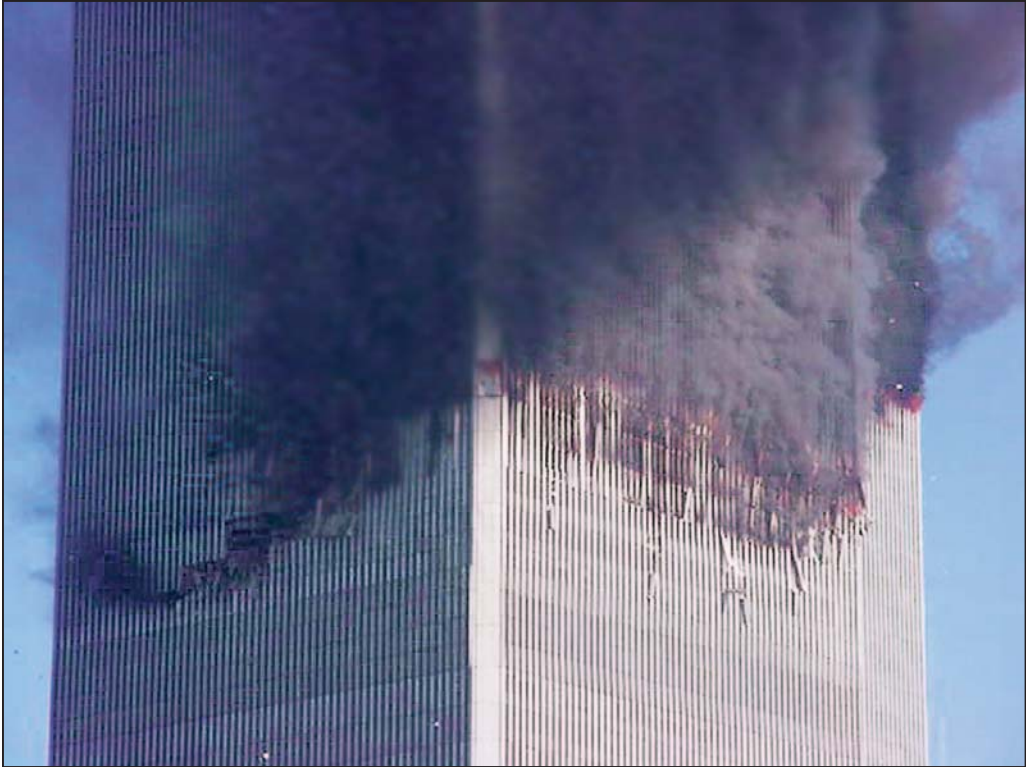
Figure 2-26 Impact damage to the south and east faces of WTC 2.

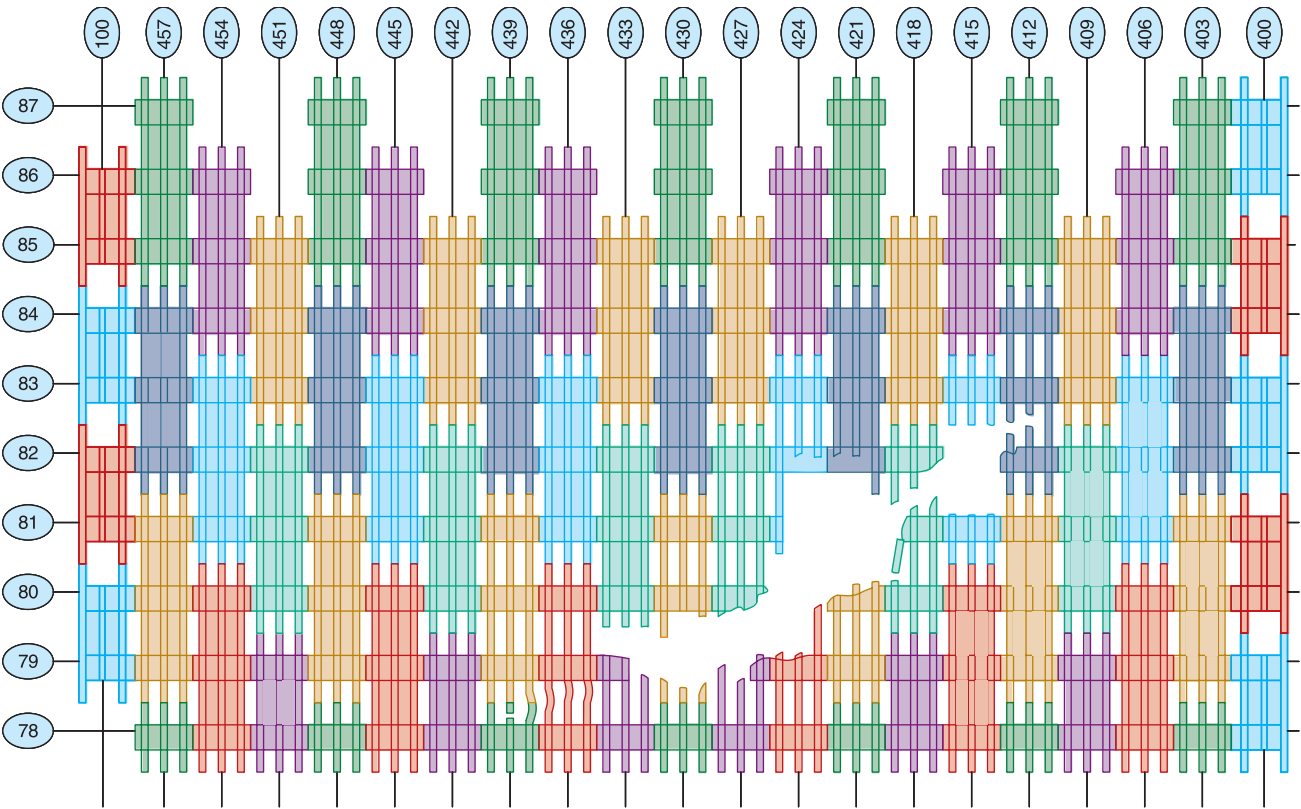
GENERAL NOTES: (1) Column damage captured from photographs and enhanced videos. (2) Damage to column lines 413-418 at levels 81 and 82 is estimated. (3) There is not sufficient information to detail damage to column lines 408-411 at levels 83-84.

Figure 2-27 Impact damage to exterior columns on the south face of WTC 2.

A second analysis was conducted to estimate the demands on columns immediately following aircraft impact and before fire effects occurred. Exterior columns were removed from the model to match the damage pattern illustrated in Figure 2-27. Although some core columns were probably damaged by the aircraft impact, the exact extent of this damage is not known and therefore was not considered in the model. As a result, this analysis is thought to underestimate the true stress state in the columns immediately after impact. The analysis indicates that most of the loads initially carried by the damaged exterior columns were transferred by Vierendeel truss action to the remaining exterior columns immediately adjacent to the impact area. If the floors at this level are assumed to remain intact and capable of providing lateral support to the columns, this raised the utilization ratio for the most heavily loaded column immediately adjacent to the damage area to approximately a value of 1.0. At a value of 1.0, columns would lose stiffness and shift load to adjacent columns. Based on this analysis, it appears that the structure had significant remaining margin

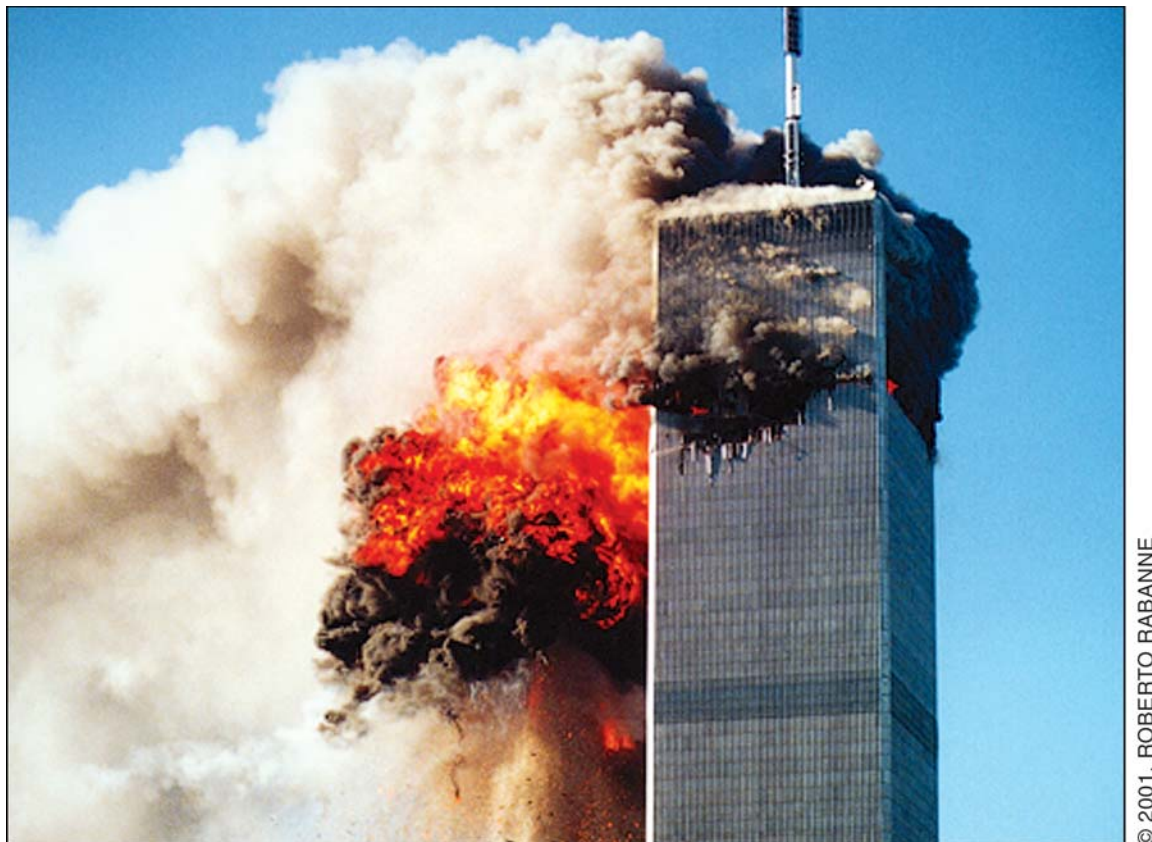
It is known that debris from the aircraft traveled completely through the structure. For example, a landing gear from the aircraft that impacted WTC 2 was found to have crashed through the roof of a building located six blocks to the north, and one of the jet engines was found at the corner of Murray and Church Streets. The extent to which debris scattered throughout the impact floors is also evidenced by photographs of the fireballs that occurred as the aircraft struck the building (Figure 2-28). Figure 2-29 shows a portion of the fuselage of the aircraft, lying on the roof of WTC 5.

Figure 2-28 Conflagration and debris exiting the north wall of WTC 2, behind WTC 1.

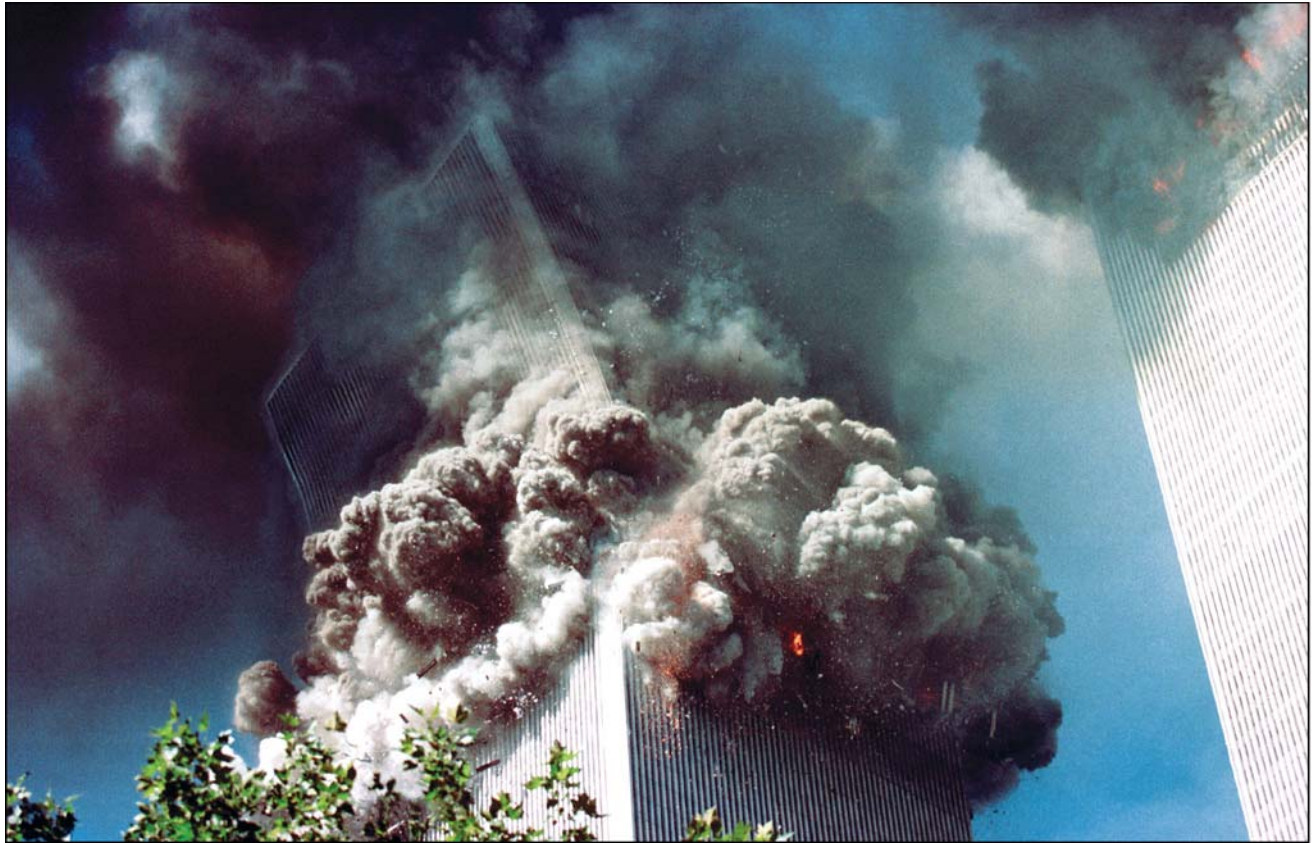
The same types of structural behaviors and failure mechanisms previously discussed are equally likely to have occurred in WTC 2, resulting in the initiation of progressive collapse, approximately 56 minutes after the aircraft impact. Review of video footage of the WTC 2 collapse suggests that it probably initiated with a partial collapse of the floor in the southeast corner of the building at approximately the 80th level. This appears to have been followed rapidly by collapse of the entire floor level along the east side, as evidenced by a line of dust blowing out of the side of the building. As this floor collapse occurred, columns along the east face of the building appear to buckle in the region of the collapsed floor, beginning at the south side and progressing to the north, causing the top of the building to rotate toward the east and south and to begin to collapse downward (Figure 2-32). It should be noted that failure of core columns in the southeast corner of the building could have preceded and triggered these events.

Figure 2-32 The top portion of WTC 2 falls to the east, then south, as viewed from the northeast.

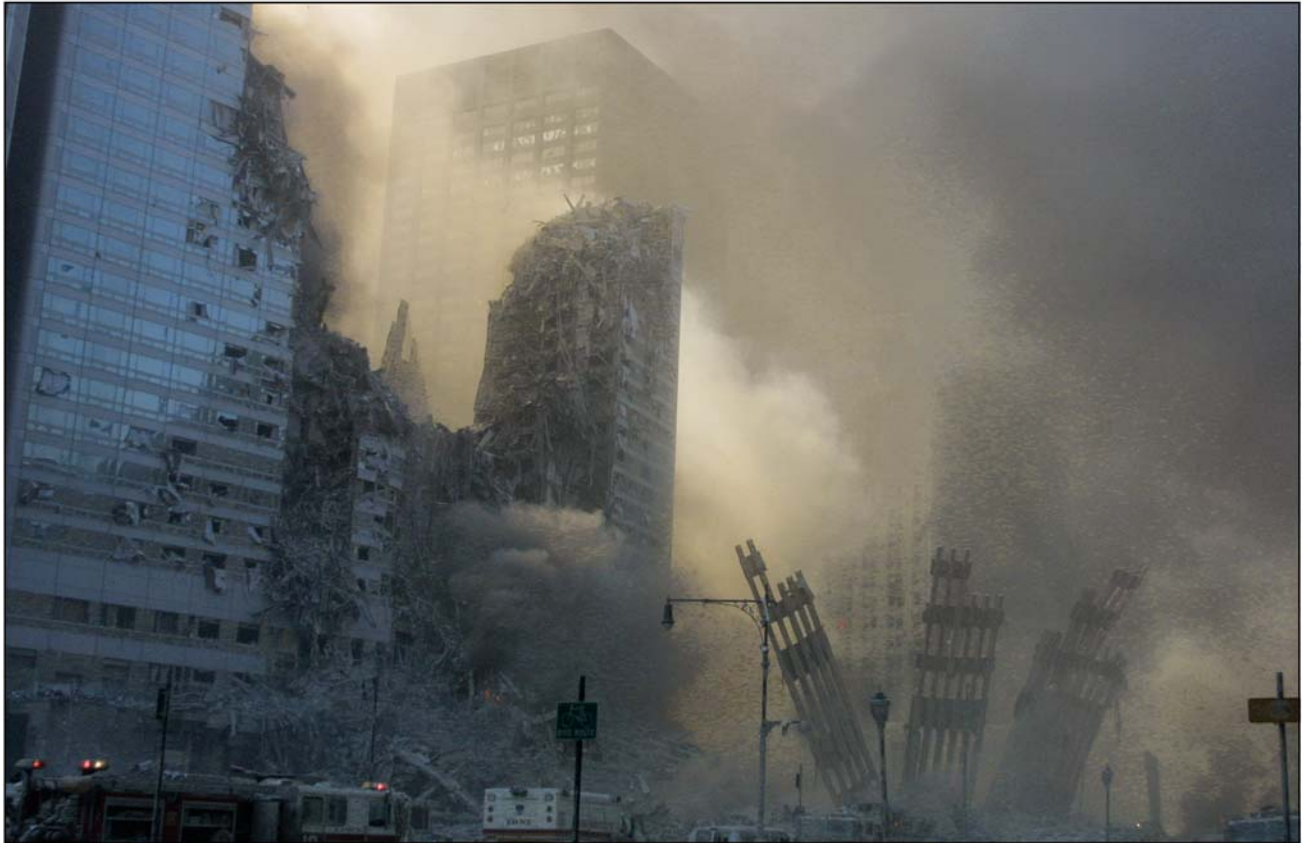
Figure 3-7 Partial collapse of WTC 3 after collapse of WTC 2.
